**Report of Dr. Brenton Cox
Regarding the May 31, 2017
Explosion at Didion Milling in
Cambria, Wisconsin**

March 31, 2023

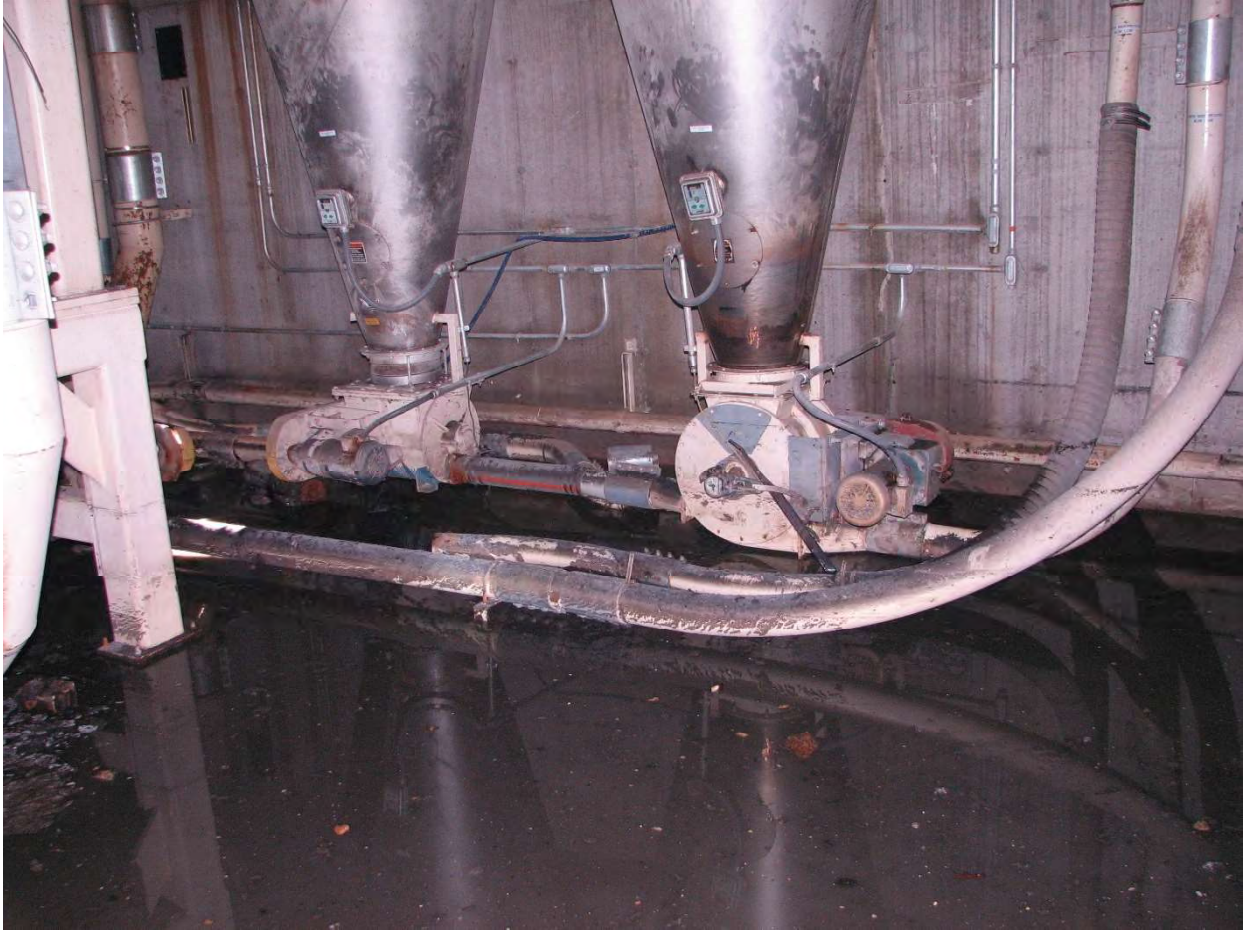
D16672 - 0157

Not shown in the PFDs is a Management of Change (MOC) performed on May 3rd, 2017, which allowed for the incorporation of the NBM into the Bran System.⁷¹ The change managed by this MOC was the connection of the “North Bauermeister blower line after [the] cyclone airlock to South Bauermeister cyclone airlock to use both [B]auermeister’s for bran production.”

Figure 16. Picture the as-found configuration, combining the discharge of the SBM Cyclone (left) and NBM Cyclone (right).

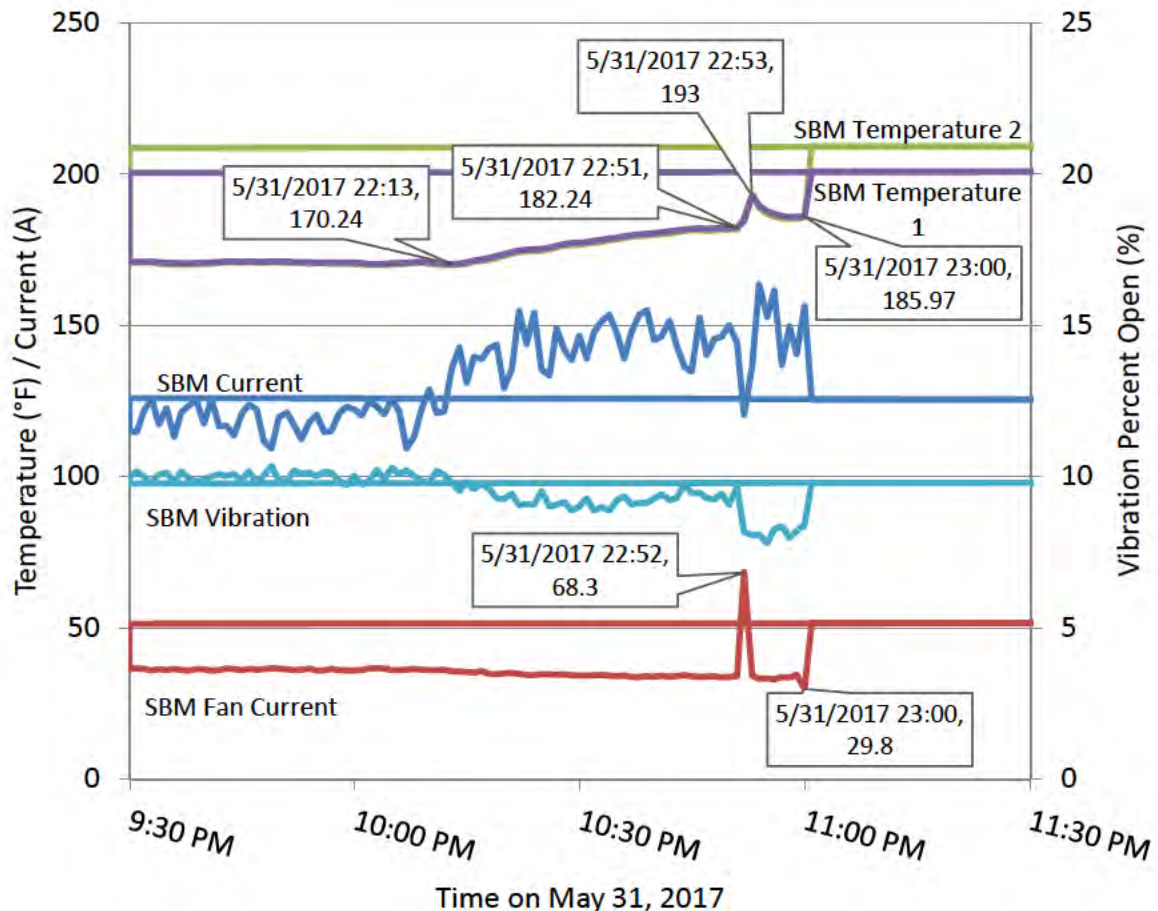
SBM gradually rose from about 170 to 182°F, concurrent with an increase in motor amps and decrease in vibration (Figure 23).⁹⁶ At about 10:45 PM or 10:50 PM, operators reported smoke and began searching for its source (see Section 2.6.4). At around 10:53 PM, the SBM temperature spiked to 193°F with a spike in fan amps occurring just before. The explosion occurred at about 11:00 PM following a small decrease in fan amps. At 11:01 PM, all data ceased.

Figure 23. Temperatures, currents (amps), and vibrations recorded for the South Bauermeister (SBM) on the evening of May 31, 2017.⁹⁷

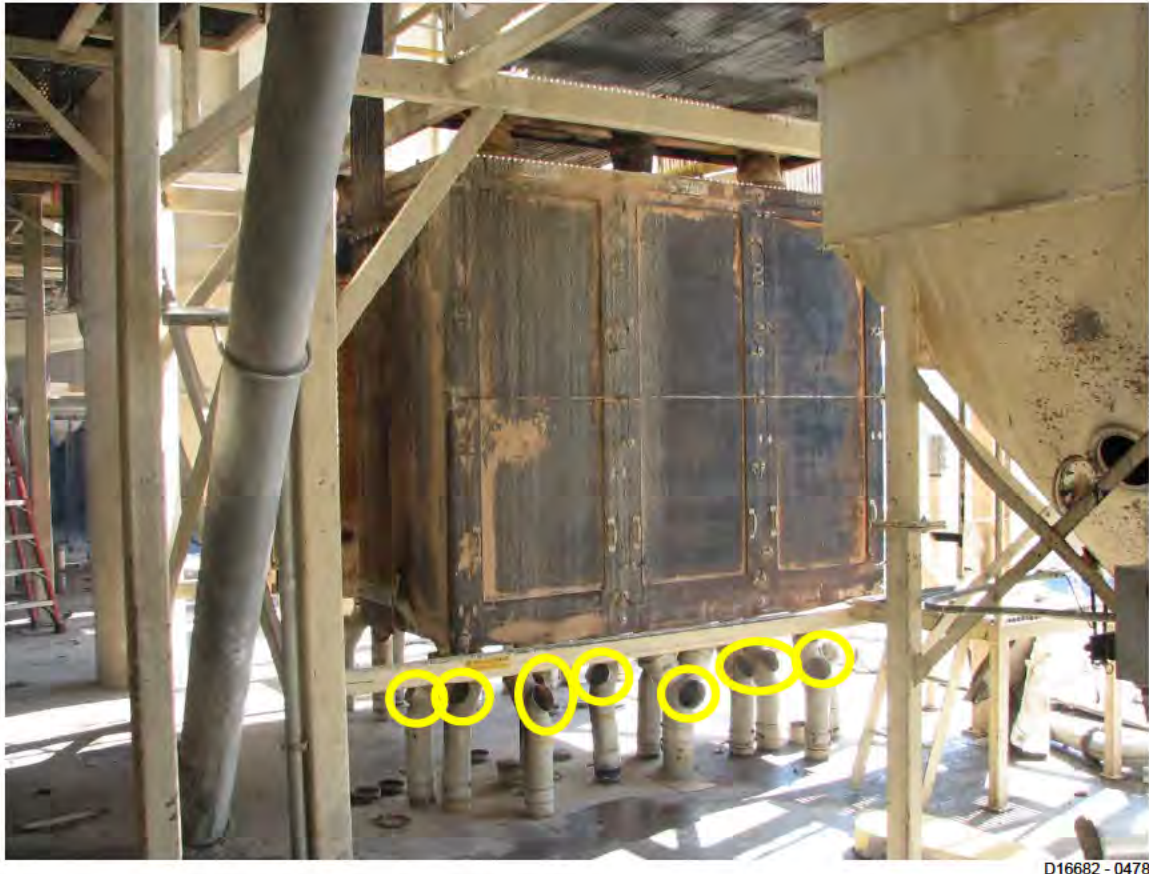
D16682 - 0478

As shown above in Figure 27, the SBM is fed by a line comprised of the +105 overs from the 6 section Bran Sifter on B4 and the two Bran Polishers on B2. The process flow diagram demonstrates that flame/pressure had multiple pathways to propagate through the +105 overs line to the 6-section Bran Sifter on the 4th floor of the B-Mill from the SBM as well as through the bottoms of the SBM Cyclone in B1. Photographic evidence demonstrates that such propagation reached the 6-Section Bran Sifter (Figure 32) as observed with the caps missing from the bottom ducts, suggesting that they were blown off due to internal overpressure.

Figure 32. Post-incident view of 6-Section Bran Sifter on 4th floor of B-Mill (B4) with detached caps.

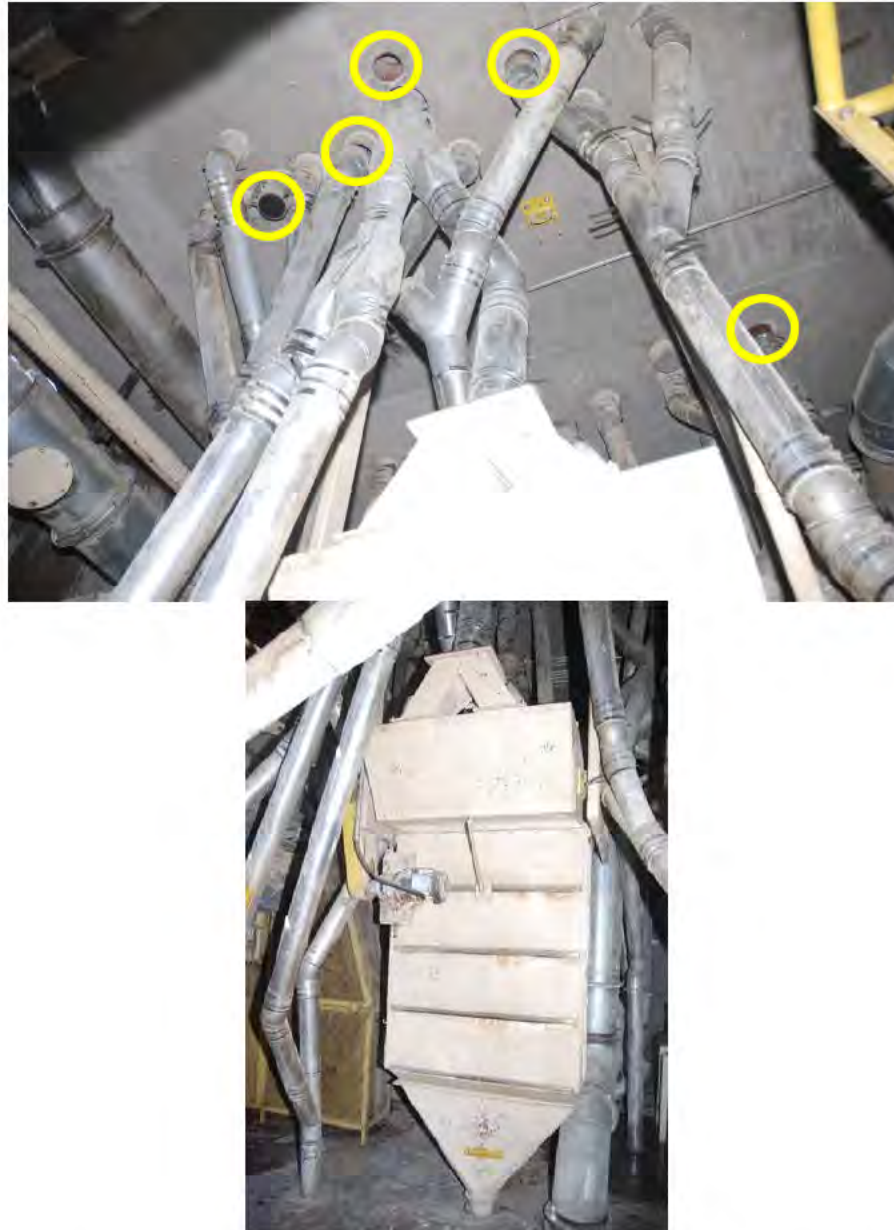
D16686 - 00996 (bottom), D16686 - 00998 (top)

Figure 34. Post-incident view of South Bran Aspirator on the 3rd floor of the B-Mill (bottom). Disconnected ducts can be seen at the ceiling level (top)—these ducts carried the discharge from the 6-Section Bran Sifter.

Disconnected ducts were also observed above the South Bran Aspirator that fed into equipment on the 2nd floor of the B-Mill, shown in Figure 34. These disconnected ducts were immediately below the 6-Section Bran Sifter and are consistent with an internal overpressure event in multiple sections of this equipment.

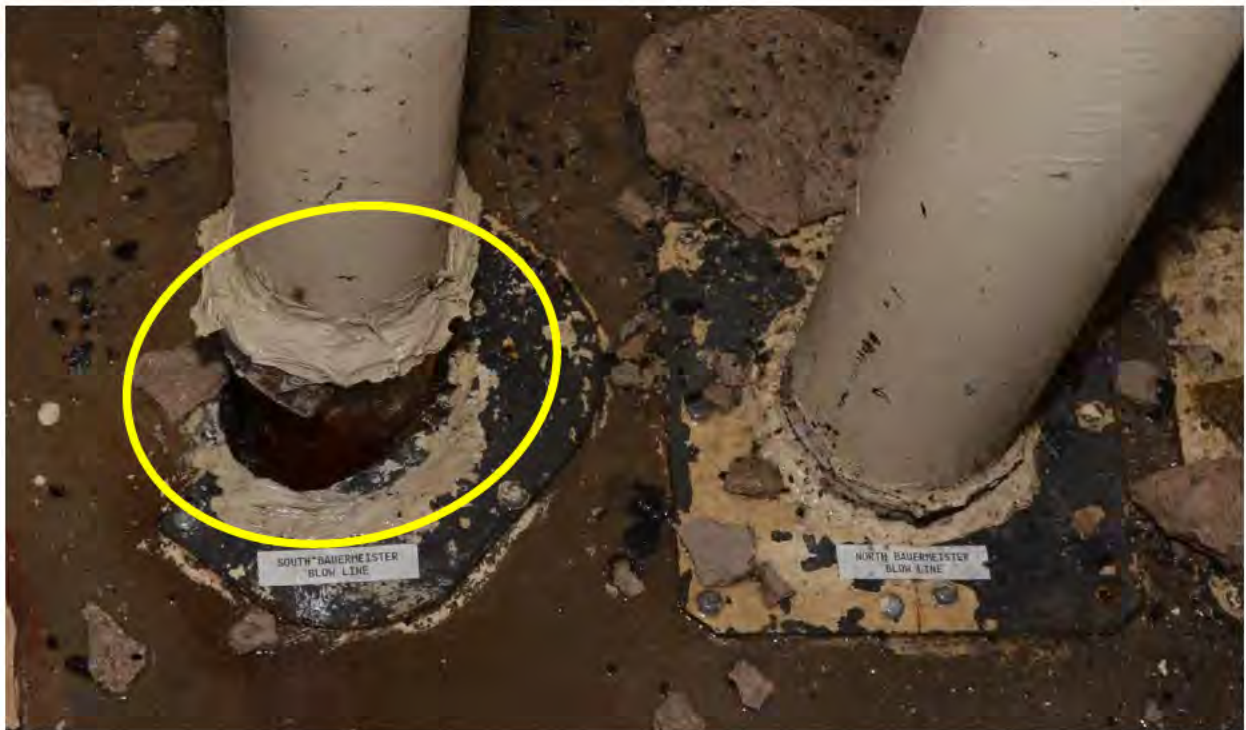
D16680 - 0749

In addition to the equipment and ducting on the 3rd floor of the B-Mill, Exponent has documented evidence consistent with internal propagation through the pneumatic conveying line ("Blow Line") leading from the SBM Cyclone discharge to the Ground Bran Cyclone on B4. As seen in Figure 39, the SBM blow line is fully separated from the floor on B3. This separation is consistent with an internal overpressure event that occurred in the SBM line with flame/deflagration propagation through the lines.

Figure 39. Post-incident view of ducting to SBM Blow Line (left) and the NBM blow line (right), which transport product from B1 to B4.

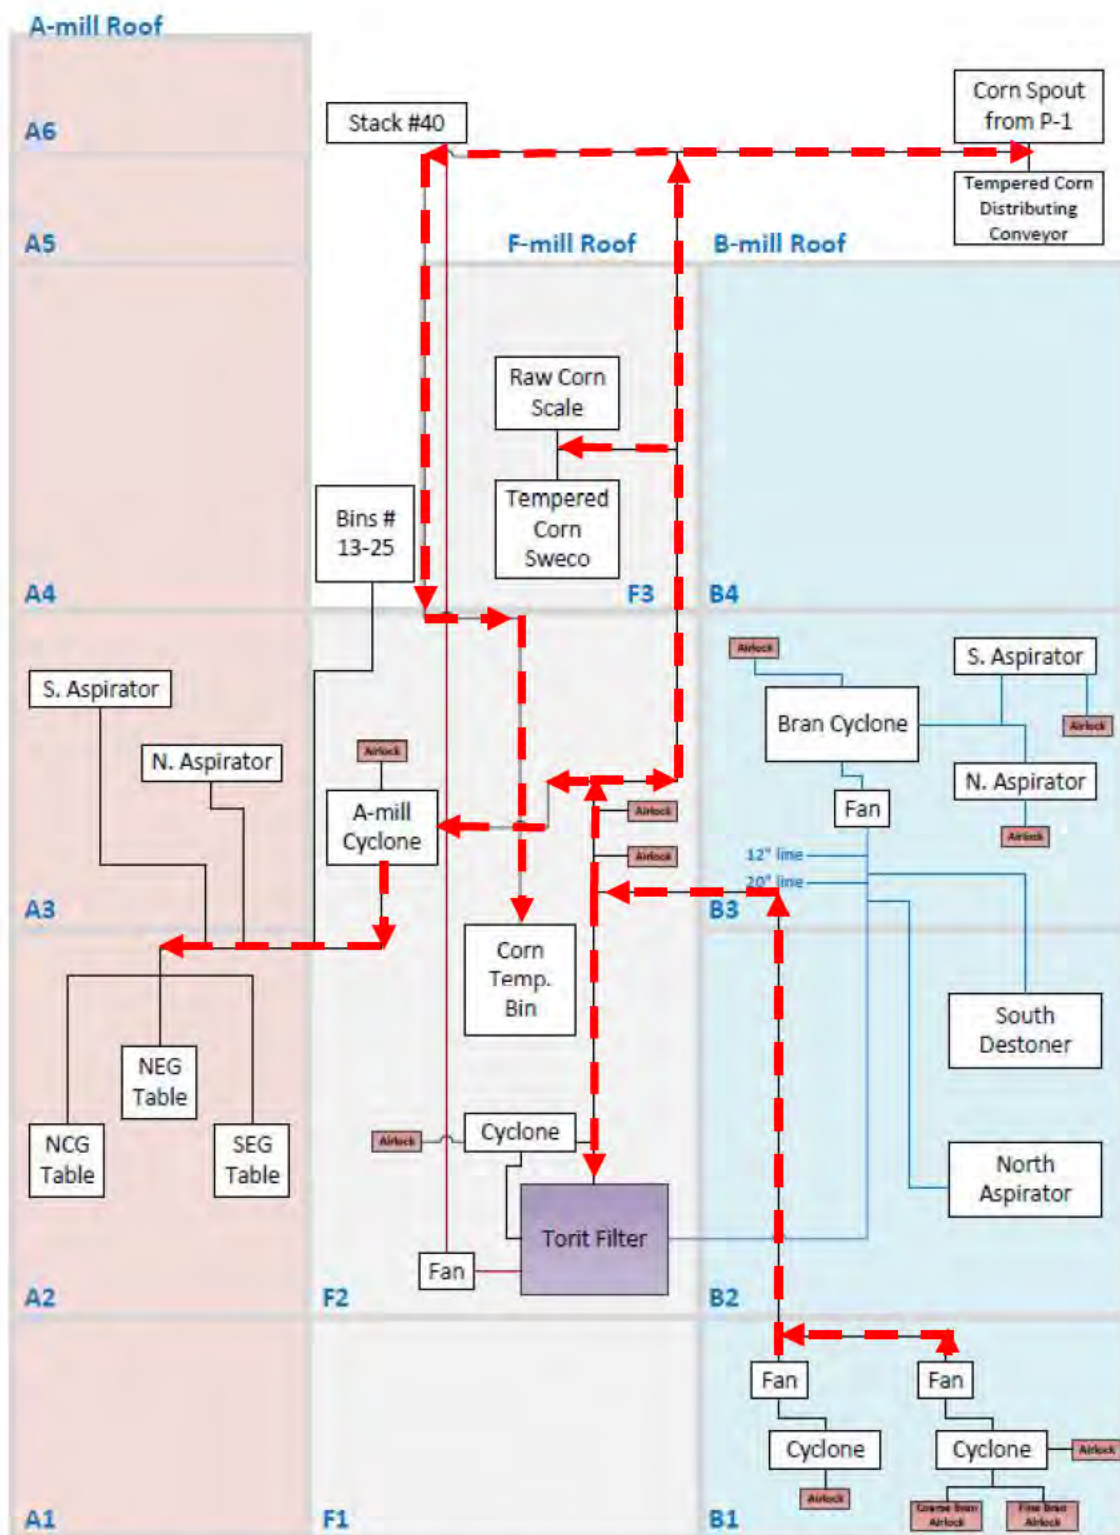
Figure 45. PFD of Torit System in B-Mill, A-Mill, and F-Mill with propagation pathways shown in red.

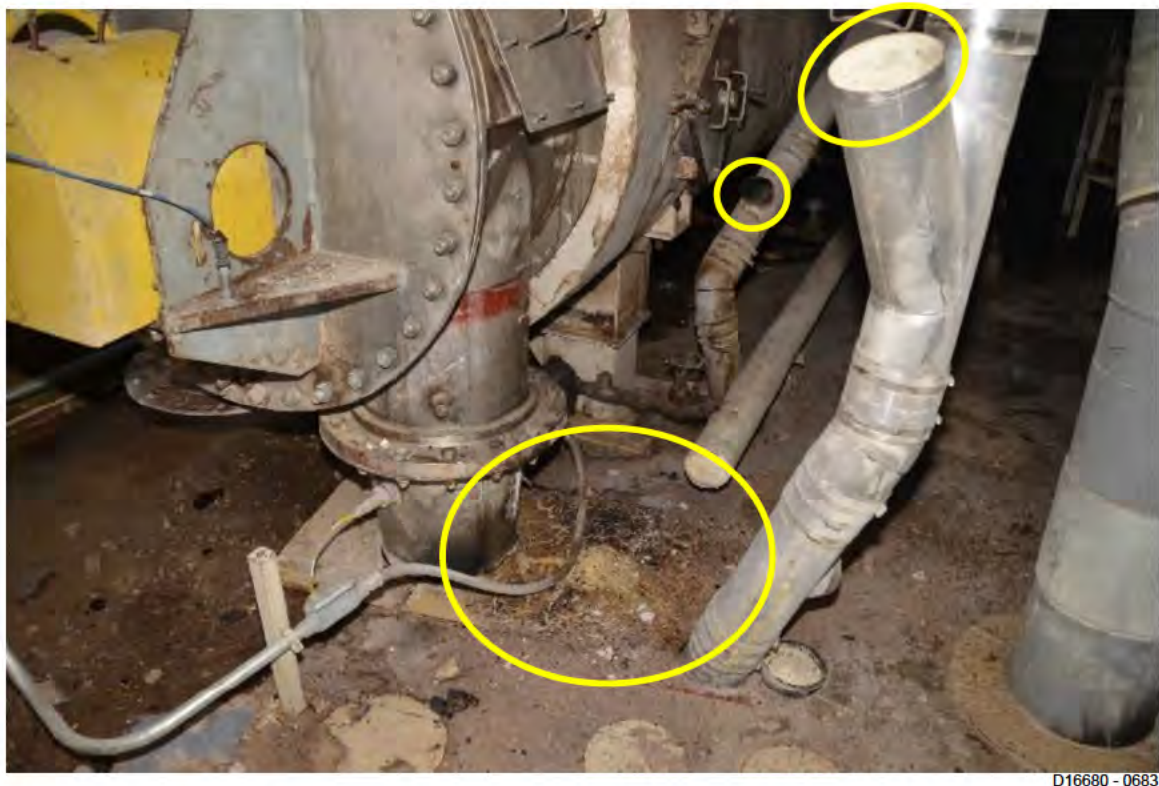
D16680 - 0683

Figure 54. Post-incident view of burned material released from separated and/or blown-open pipes on 2nd floor of B-Mill.

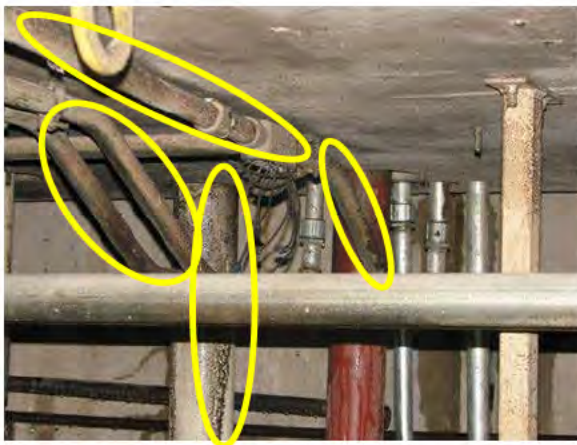
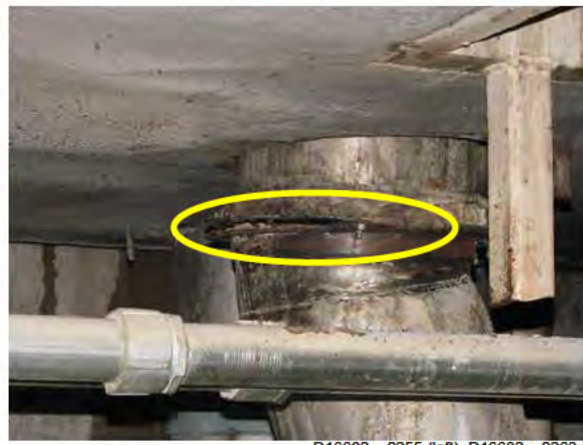
D16682 - 0255 (left), D16682 - 0263 (right)

As described in Section 3.2, the explosion propagated internally through the ducting and equipment across the mill. Additional open pipes with evidence of burned material as a result of product ejected from internal ducts is shown below in Figure 54. Figure 55 depicts the separated duct between Expander 1 and the Expander 1 Solidaire. Deposits of burned material ejected from the separated duct can be seen on adjacent piping.

Figure 55. Post-incident view of separated duct between Expander 1 and the Expander 1 Solidaire near the ceiling of 2nd floor of B-Mill (right) ejected burned product horizontally (left).

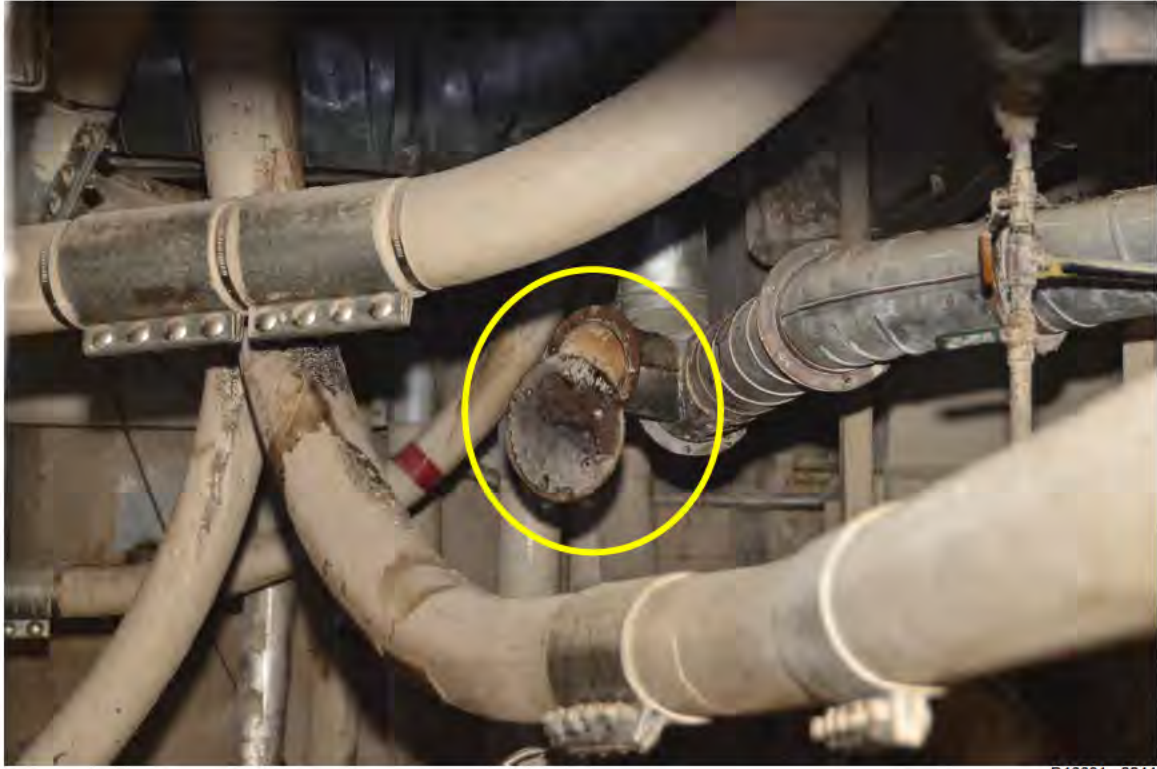
D16681 - 0044

The A-Mill also shows evidence of blind ducts that experienced an internal overpressure event and of soot deposition from burned, ejected material, as shown in Figure 66.

Figure 66. Post-incident view of a separated flange in A1.

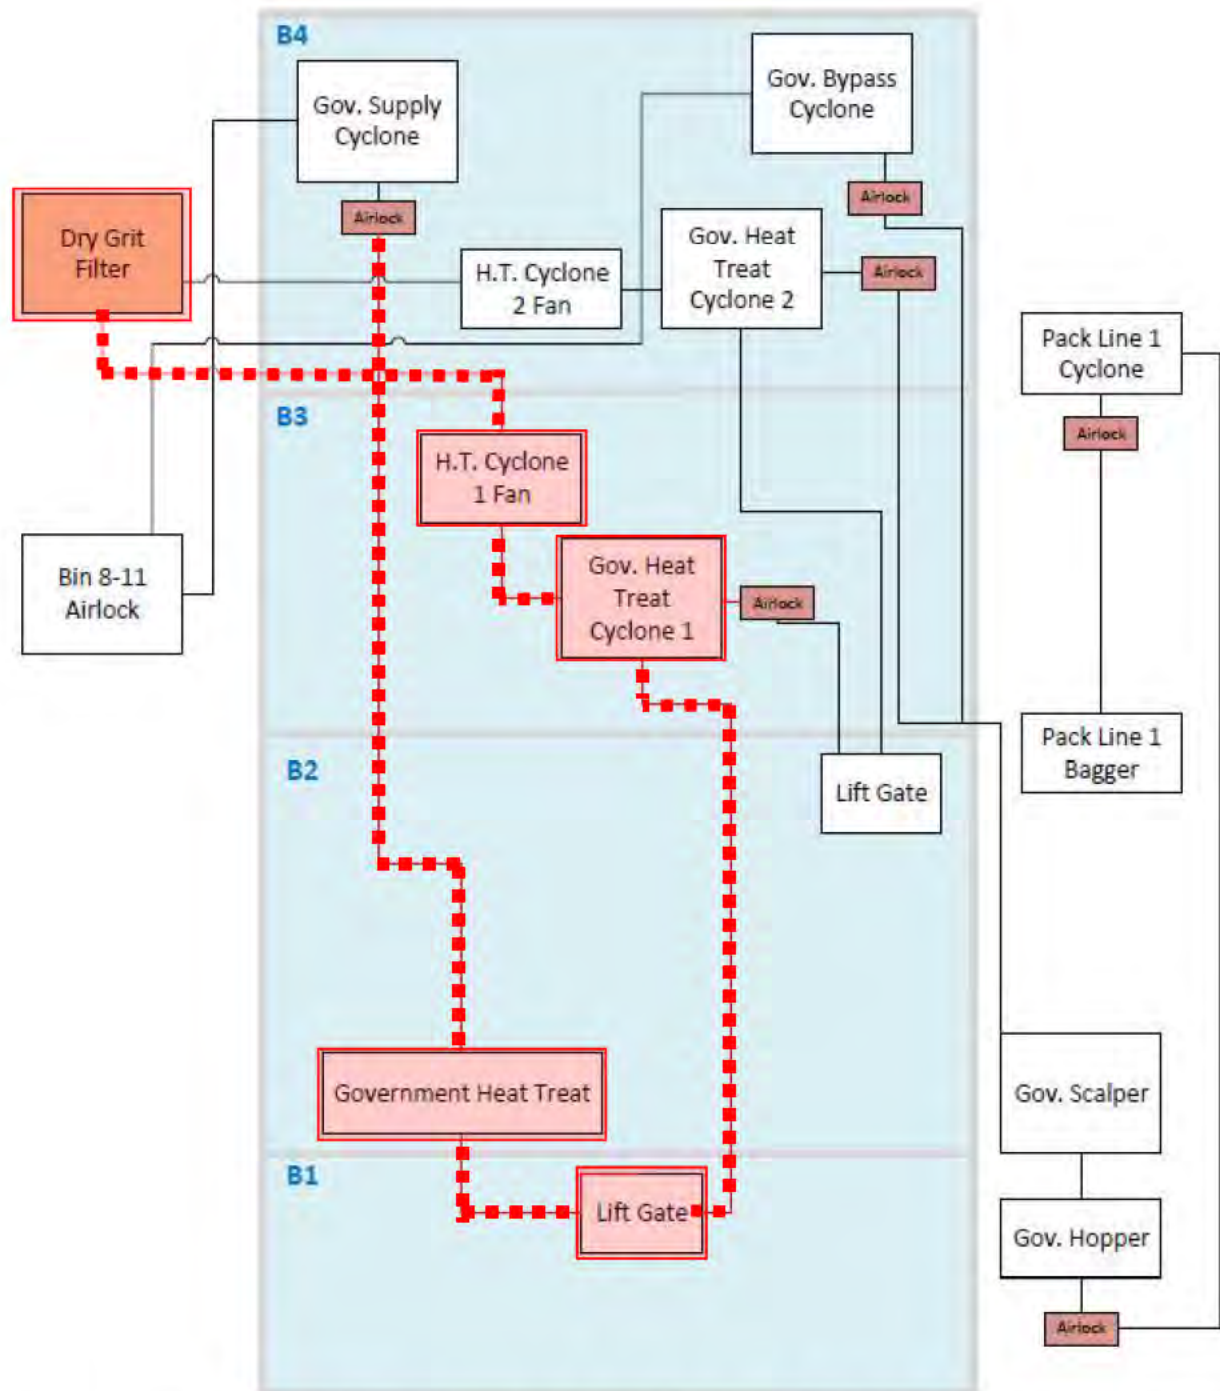
Figure 78. PFD of the Government System in the B-Mill with propagation pathway shown in red.

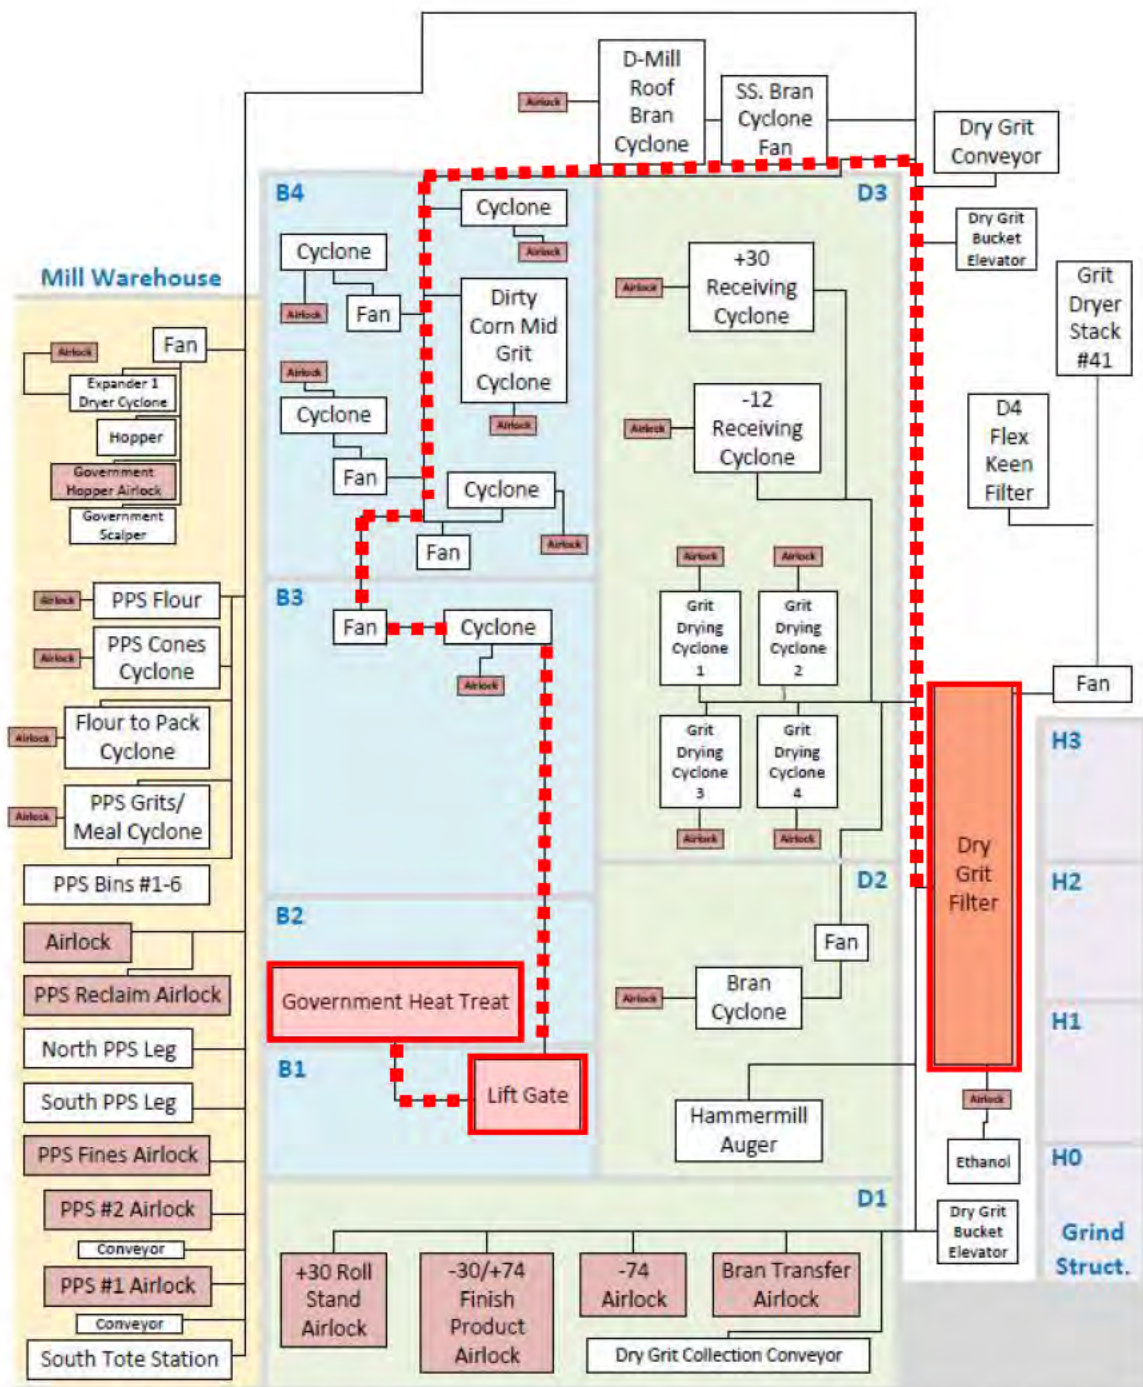
Figure 81. Flame Propagation from B1 to the Dry Grit Filter, which is connected to rest of Mill (Warehouse, B-Mill, D-Mill, and Grind Structure). The propagation pathway from the government system to the dry grit filter is shown in red.

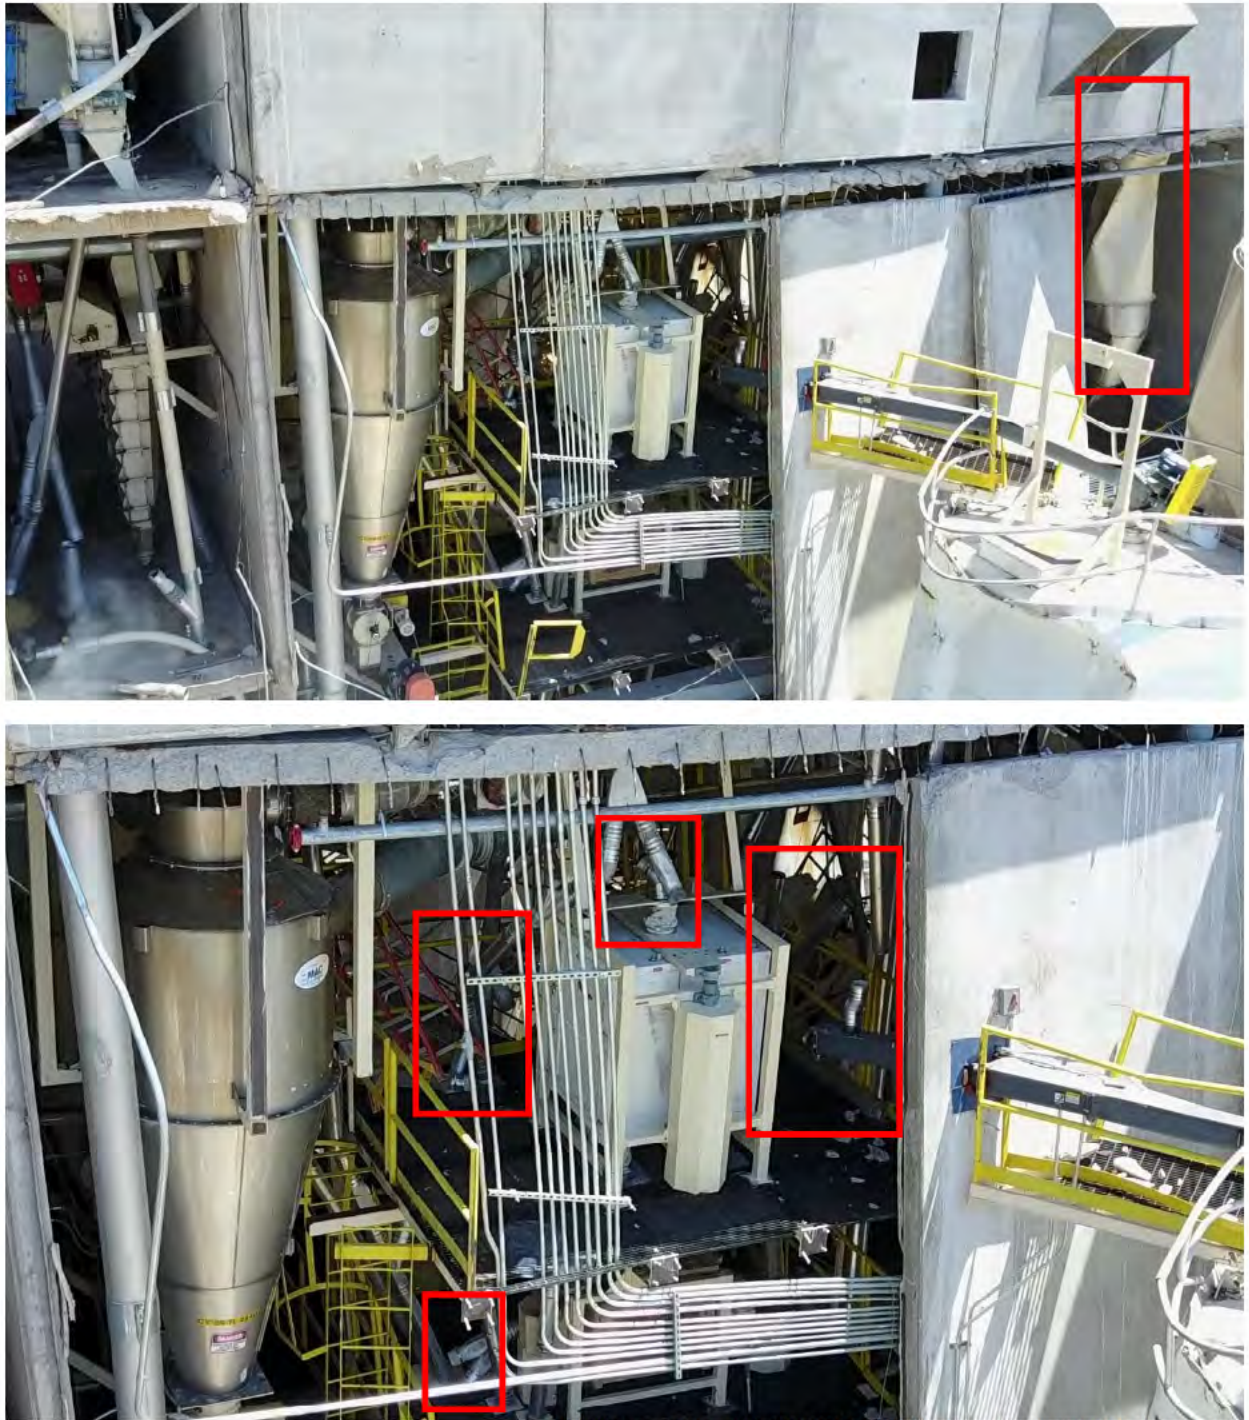
06/15/17 Drone Footage (DJI_0002 MOV). DJI_0002 - frame at 5m52s DJI_0002 - frame at 6m8s

Drone footage from the D-Mill showed separated ducts in Figure 74 (described above in Section 3.3.2 with material ejected into the D-Mill). Additional drone footage from outside of the D-Mill captured other ducting and equipment. From Figure 85, internal overpressure is observed due to caps blown off ducting attached to equipment and collapsed ducting (described in more detail in Section 3.4.2.3.1). The Dry Grit Filter ducts are connected to multiple pieces of equipment in the D-Mill including D1 but no drone footage or photographs inside were captured due to the inaccessibility of location and building stability concerns, respectively.

Figure 85. Post-incident aerial view of D1 equipment showing internal overpressure.

From Figure 85, multiple disconnected ducts are observed. In the top screenshot from drone footage, a collapsed duct can be seen, which is a phenomenon associated with the vacuum pressure that follows an internal deflagration.²⁰¹ In addition to the equipment throughout the D-Mill, ducting from the Dry Grit Filter to the other areas of the mill can be observed on top of the D-Mill connected to the D-Mill Bran Cyclone and fan in Figure 86.

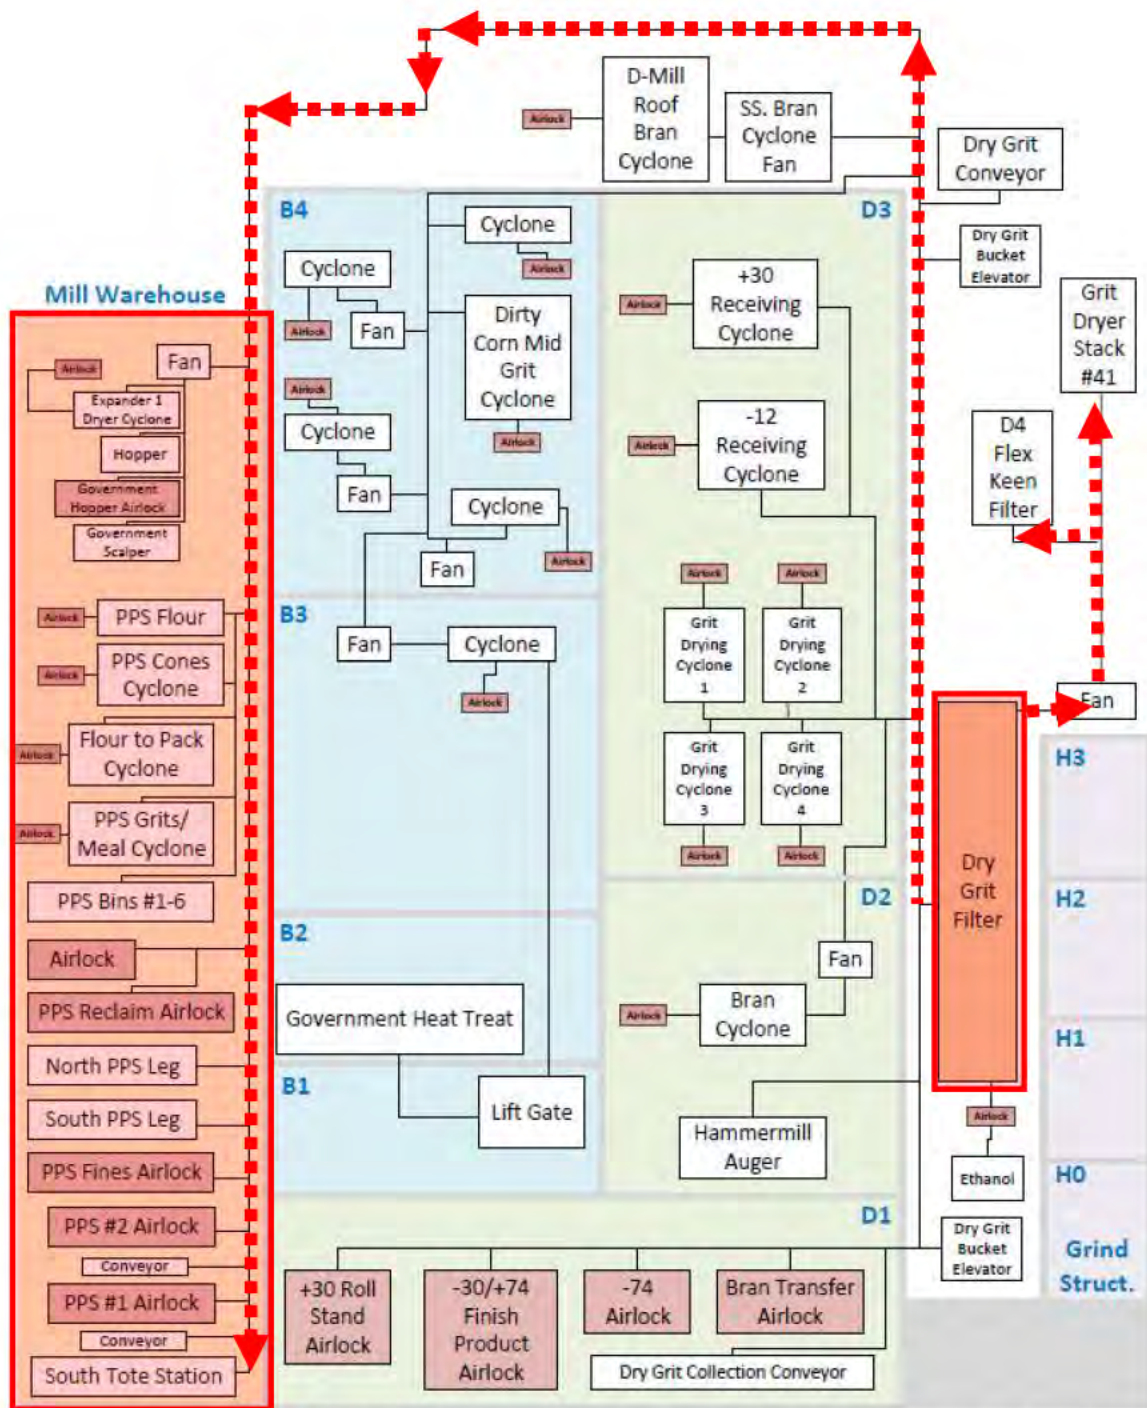
Adapted from REF-MILL-ENG-7803-01 F6 Dry Grit Filter S#3.pdf and Highlighted PFDs - Government Heat Treat and LO.pdf

Figure 87. Dry Grit Filter to rest of Mill (Warehouse, B-Mill, D-Mill, and Grind Structure) with propagation shown in red.

As shown in the F6 Dry Grit Filter PFD,²⁰² the Dry Grit Filter spanned the D-Mill, B-Mill, and Warehouse in addition to the roof of the Grind Structure (also referred to as “Hammermill”). In the warehouse, the Dry Grit Filter was connected to multiple pieces of equipment in both the Pack area and the Product Protection System (PPS) area. While the warehouse was inaccessible after the incident, the PFDs show that this system was interconnected across multiple other areas of the mill through the Dry Grit Filter header. Due to the extent of damage and collapse in these areas, the extent of internal propagation into the Pack and PPS areas could not been determined, but it is likely that some amount of propagation occurred given the extensive evidence of propagation elsewhere in the Dry Grit Filter header.

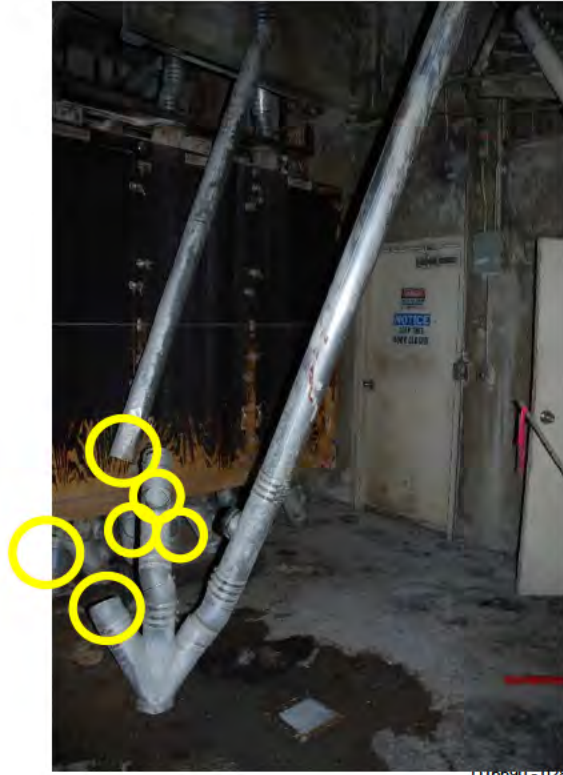
D16690-0281

Figure 88. Post-incident view of Grit/Flour Sifter (M-11021) on the 5th floor of the A-Mill.

Both of the sifters connected to the Dry Grit Filter in the A-Mill showed internal overpressure, observed from the caps blown off the bottom ducts from these pieces of equipment. These sifters fed into Reduction Roll Stands on A1, which fed the Sizing Flour 6-Section Sifter on the 3rd floor of the A-Mill, shown in Figure 90.

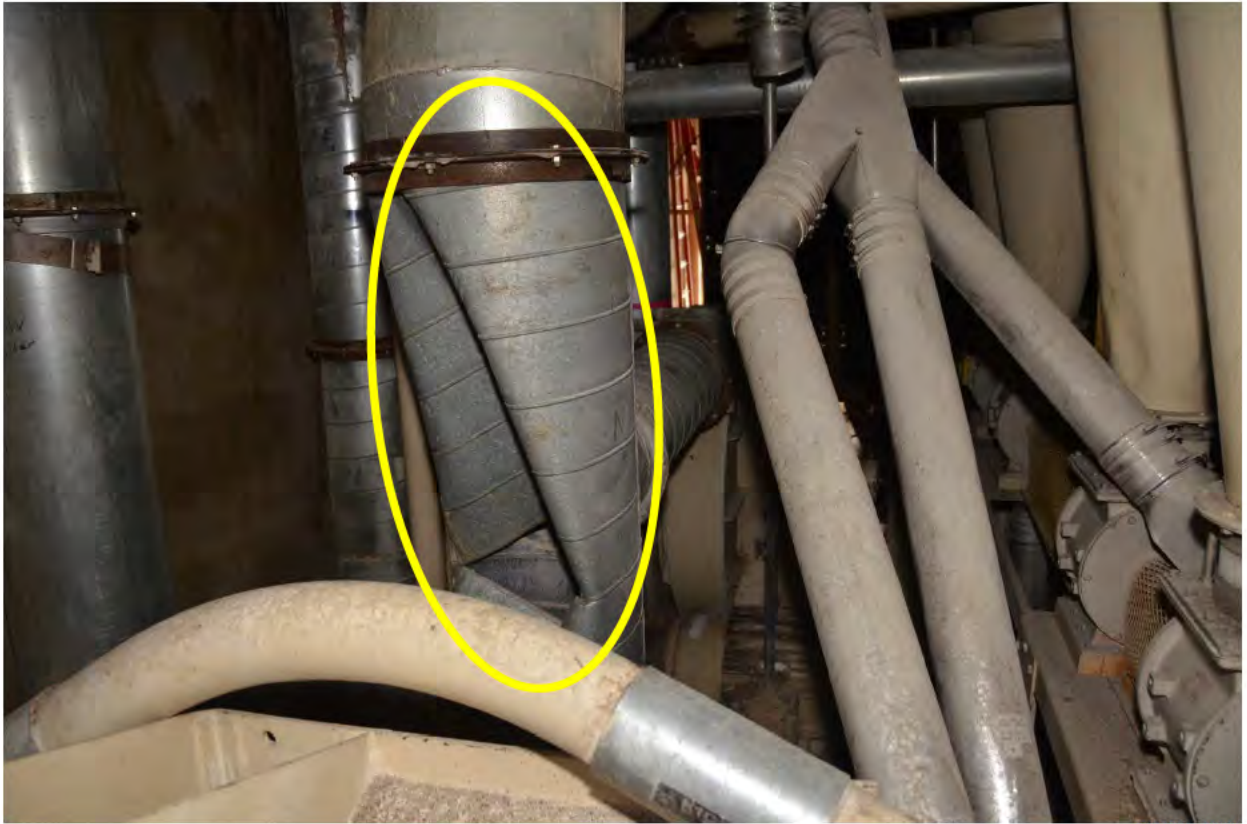
D16681 - 0382

Another apparently collapsed duct was also observed on the 4th floor of the A-Mill as shown in Figure 95. Additional separated ducting was also observed on the 4th floor of the A-Mill, shown in Figure 96.

Figure 95. Post-incident view of flattened duct from internal overpressure on the 4th floor of the A-Mill.

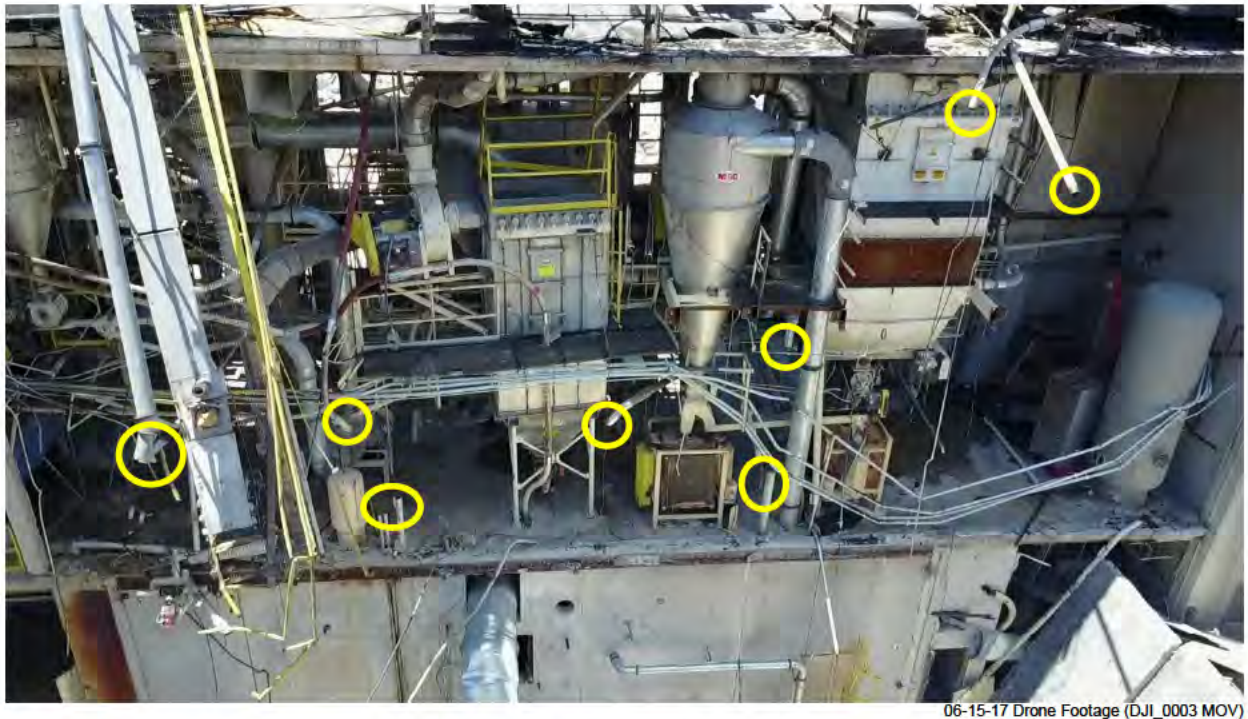
06-15-17 Drone Footage (DJI_0003 MOV)

While the Dry Grit Filter does not appear to have been connected directly to equipment in the Bran System in the B-Mill, it is connected to other systems inside the B-Mill such as the Government System,²⁰⁷ PPS fractionation system,^{208,209} and Grit Drying System.²¹⁰ Few photographs of the fourth floor of the B-Mill exist because it was considered unsafe for long-term occupation, but multiple ducts separated over the course of the incident, as observed in Figure 97.

Figure 97. Post-incident drone footage of the 4th floor of the B-Mill.

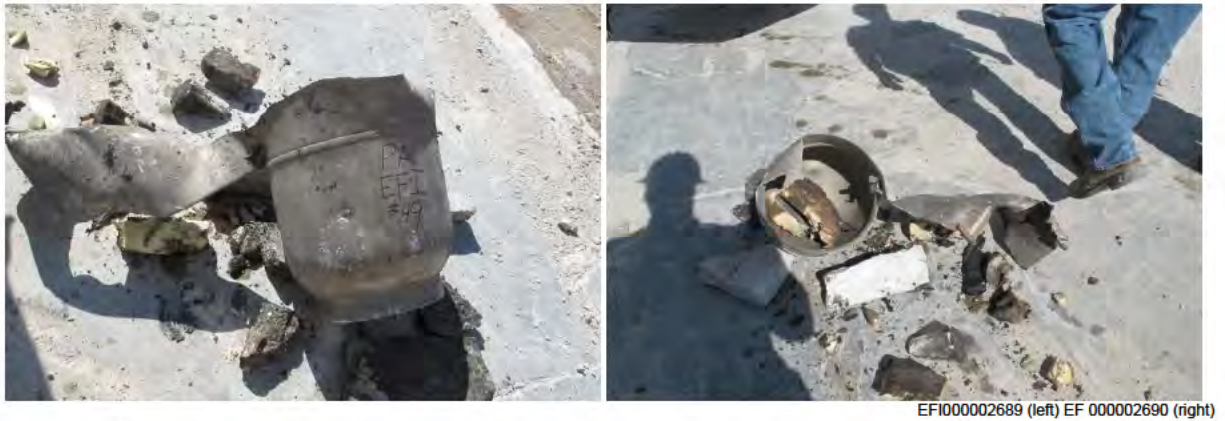
Figure 100. The LP-gas cylinder most likely associated with the fork truck

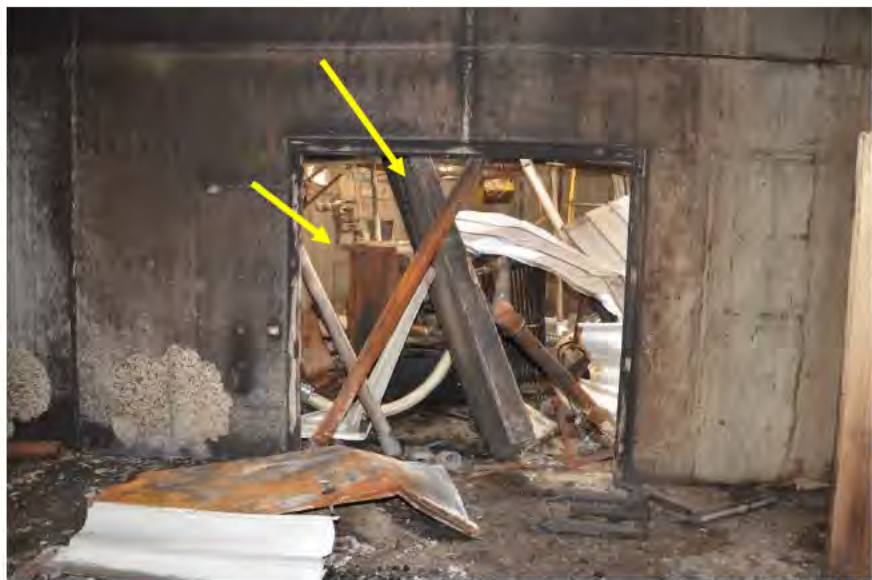
D16681 - 0074

A transformer was damaged by a panel that most likely fell from the B-Mill, resulting in a fire involving the mineral oil contents of the transformer. Burning liquid erupted and/or poured from the transformer into the Center Bay of the Truck Loadout area. The spalled concrete on the walls in the center bay is consistent with the rapid and intense heat development from an ignitable liquid fire.²¹³ The soot development on the walls and ceiling is consistent with a prolonged fire.

Figure 103. Transformer that was impacted by a panel that most likely fell from the B-Mill, resulting in a fire involving transformer oil. Yellow arrows indicate the locations of the panel and transformer.
